| TO: | Historic & Architectural Preservation Commission | |
|---|--|--|
| RE: | 110 East High Street – Re-classification | |

PROJECT ADDRESS: 108-110 E. High Street, Oxford, Butler County, OH

FROM: Naylor Wellman, LLC, Preservation Consultants

# ARCHITECTURAL and HISTORICAL SIGNIFICANCE REPORT

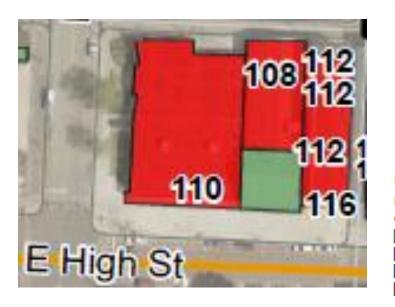
This painted brick two-story building has an altered assymetrical front facade. The 5 second story windows are one over one. There are three entry doors and one plate glass window on the first floor. This is one of the oldest buildings in the commercial district. Except for a grocery store and cobbler shop, this was primarily a residential use until the 1900's. From 1970 to 2016 Follett's Miami Book Store occupied the commercial space. Prior to the book store a car dealership, printing company and a music store occupied the space.

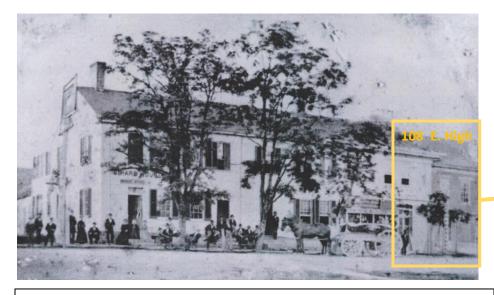
Girard House to the left has been demolished and <u>108 E. High</u> to the right. Photo, ca. 1860s Source: Smith Library of Regional History

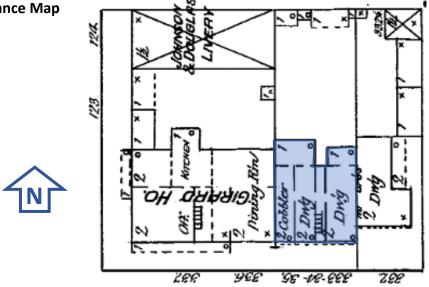
#### 1887 Sanborn Fire Insurance Map

By 1887, the two-story building with slate roof was composed of two dwelling units flanking a central stair each with a rear one-story wing. The west dwelling unit had an adjoining cobbler area which shared the rear wing. A dotted line indicates a full-width canopy, porch or overhang at the façade. Note historic address is – 333, 334, 335 High Street.

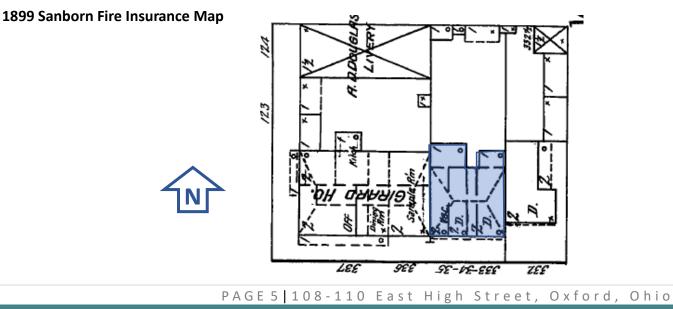
By 1892, the two-story building with slate roof was composed of two dwelling units with rear one-story wings remaining. A side-gabled roof is noted. The canopy, porch or overhang at the façade remains. The cobbler area is vacant. Note the configuration remains the same in 1892 and 1899.

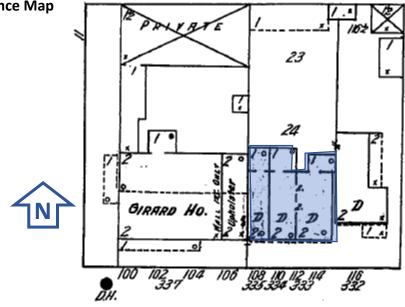
#### 1911 Sanborn Fire Insurance Map

By 1911, the two-story building with slate roof was converted to three dwelling units with the two easternmost units connected. The west cobbler unit was converted to an additional separate dwelling unit with separate rear one-story wing. The canopy, porch or overhang at the façade remains. Interior changes indicate that the central stair was removed/altered. The first floor fenestration pattern was completely changed from the ca. 1860s appearance. Note that the addresses were changed to 108, 110, 112, 114 perhaps indicating an upstairs unit.

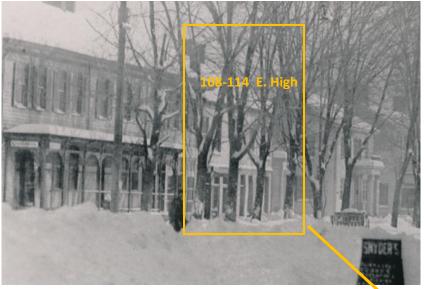
Girard House (100 E. High) and 108-114 E. High Photo, 1918 Source: Smith Library of Regional History

Note: First Floor Façade with multiple slender bays covered by a full length slightly projecting roof.

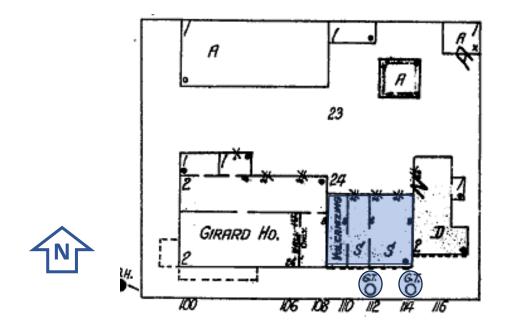
#### 1925 Sanborn Fire Insurance Map

By 1925, the two-story building with shingle roof was converted to three connected commercial use units. Stores reside in the easternmost units and a "vulcanizing" business in the western unit with rear one-story wings removed. The canopy or porch at the façade remains. Two Gas Tanks are noted in the front of the building Address- 108, 110, 112, 114 High Street.

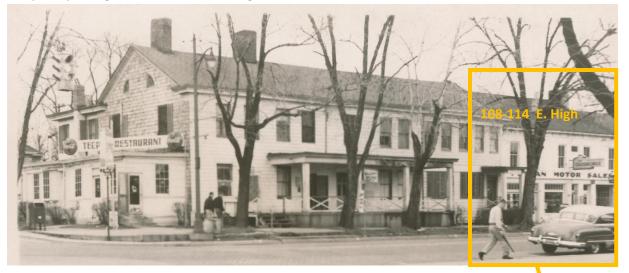
Girard House (to the left) and Fryman Motor Sales (Oldsmobile) at 108 E. High (to the right) until 1957 Photo, 1953

**First Floor Façade Commercial Alterations:**

- First (West) bay Divided lite double door with divided lite transom
- Second Bay Divided lite single door entry with transom
- Third Bay Fixed pane display window with divided light transom
- Fourth Bay 2 single door entries with tramsoms
- Fifth (East) Bay Garage door opening

Note central chimney at roof below ridgeline

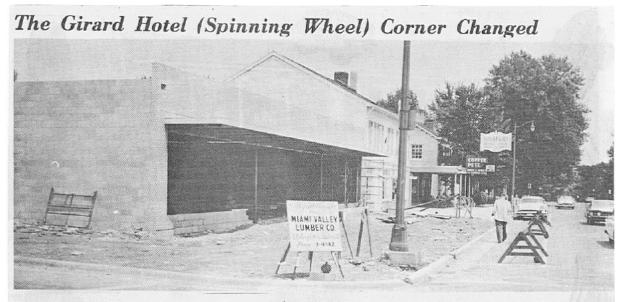
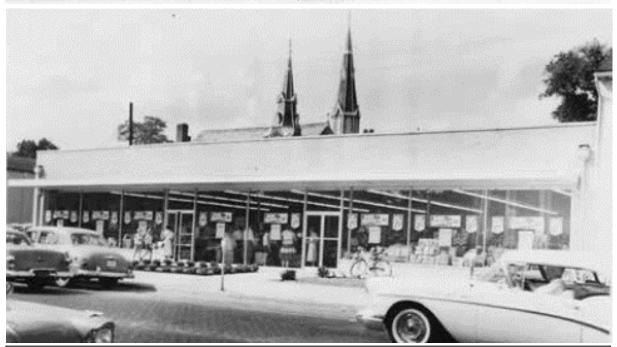
These pictures further detail the history of the Girard Hotel (Spinning Wheel) property previously referred to in this series. The century-old hotel building at the northeast corner of Poplar and High was razed in 1955 and in 1959 replaced by a buff-brick, one-story structure. The photo above shows the building during construction; note beyond it, the building housing Goldflies Music and Cullen Printing, the extended portico of Coffee Pete's, and the old Dr. J. N. Bradley

residence which later housed Sigma Alpha Epsilon and Tau Kappa Epsilon fraternities, since being replaced by the University Arcade building. The photo below shows the corner building, now occupied by The Boar's Head, as it appeared when the W. W. Mac Co. opened its store there in 1960, Later the west corner location was sectioned of and used for some time by Capitol Dry Cleaners. — Staff Photos

W.W. Mac Company (dime store) replaces the Girard House which was razed in 1955 Photo, ca. 1960 Source: Smith Library of Regional History

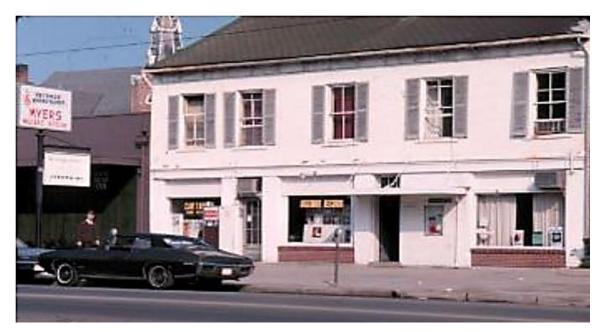
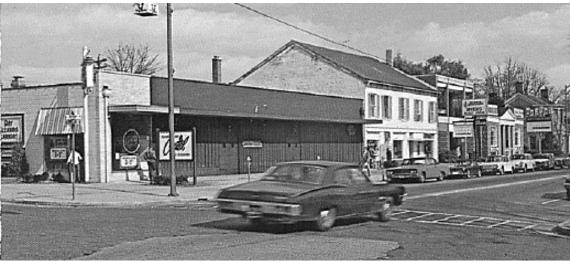
108 E. High at the center Windowless bar called the Boar's Head Inn with a dry cleaner at west (left) end Photos, ca. 1969

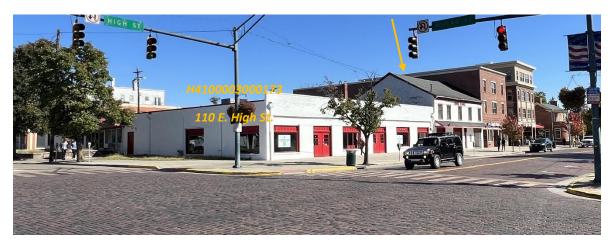
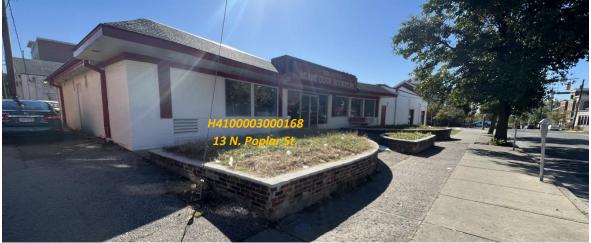
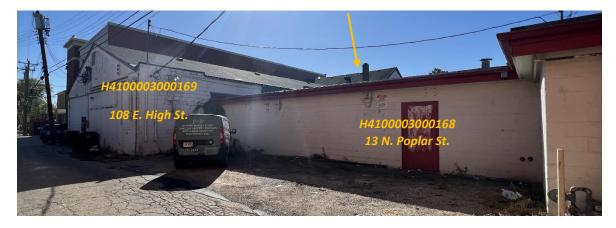
The original 1839-59 Federal style front portion of 108 E. High Street/Parcel H4100003000172 has been engulfed by additions to the west and rear which are physically connected and impacting historic integrity.

The west wall of the front portion of 1839-59 108 E. High was removed and replaced with contemporary brick and steel I-beams; contemporary wood beams and plywood under decking are installed throughout the ceiling. There is no evidence of the historic west brick wall elevation, wood joists or post and beam construction representative of the era. There are no interior demising walls as noted in historic Sanborn Fire Insurance maps.

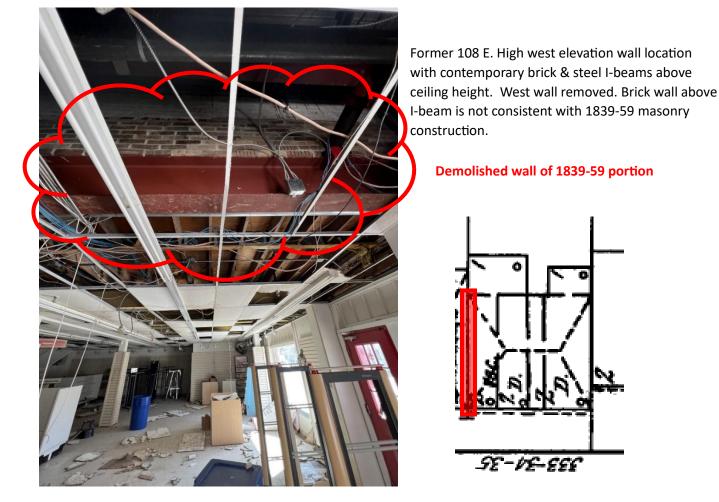
View of front original 1839-59 portion of 108 E. High St. – from former location of west elevation wall, camera direction east. No historic fabric remains.

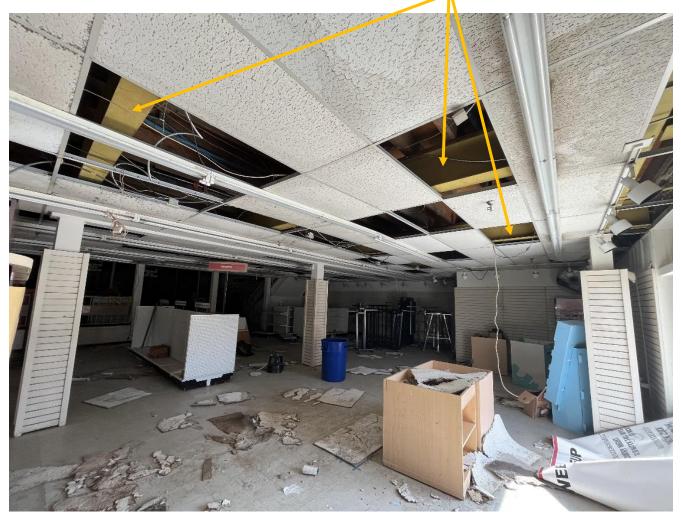
View of front portion of the original 1839-59 portion of 108 E. High – brick & steel I-beams throughout above dropped ACT ceiling. No historic fabric remains.

View of 108 E. High St. interior, camera direction northeast. Note north wall has been removed.

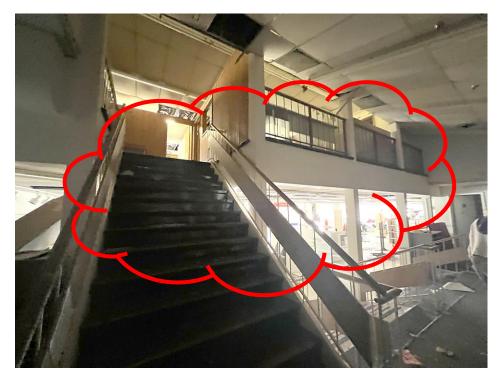
The rear north elevation of the front portion of 108 E. High has been demolished, the demolition includes the north half of the building both first and second floor from the ridge of the side gable, reducing the building by half.

Demolished rear half of 1839-59 portion

View of location of former rear north elevation, camera direction south

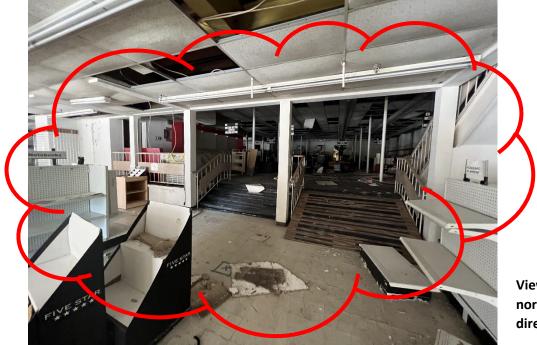
View of location of former north rear elevation, camera direction northwest

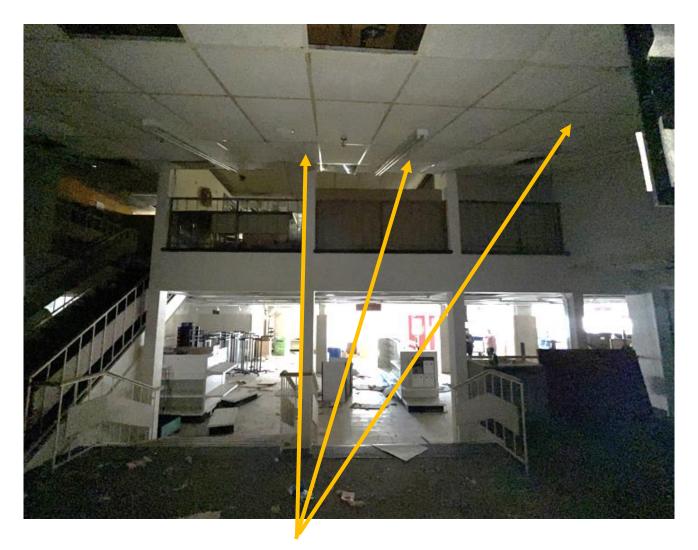
View of Gable Ridge, roof angle of original 1839-59 building, showing the rear half of the 1839-59 demolished, camera direction south.

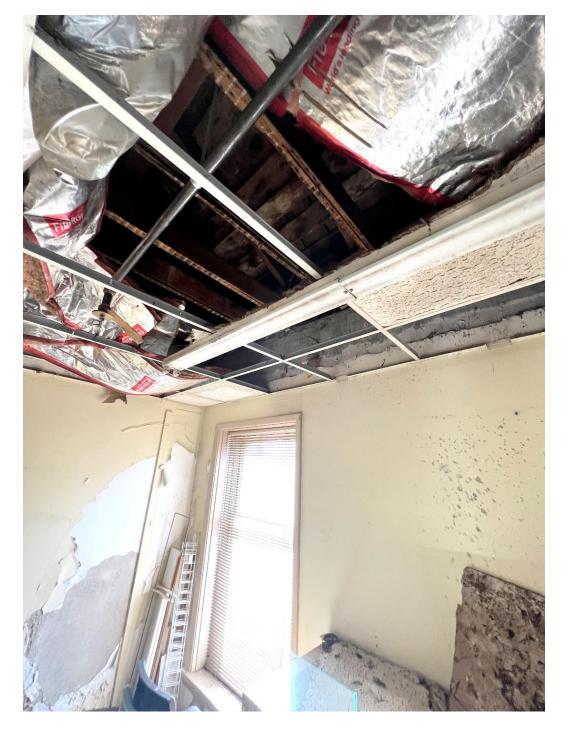
Second floor roof joists and sheathing – appear milled.

Second Floor - View of roof construction, camera direction southeast, up.

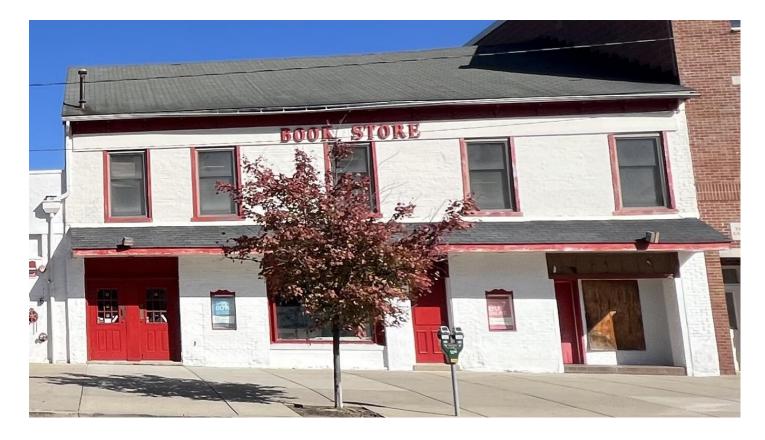
The 1839-59 108 E. High front portion two-story five-bay façade is composed of white painted brick and abuts the city sidewalk. The first floor has been altered from previous uses including multi-family residences, commercial stores, service station, car dealership, retail stores and most recently as Follett's Miami Co-op Bookstore. Non-historic canopy, doorway openings, windows and doors remain.

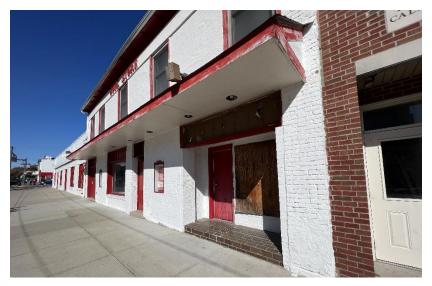
A non-historic contemporary full-width asphalt shingled wood shed roof with recessed lighting shelters the first floor.

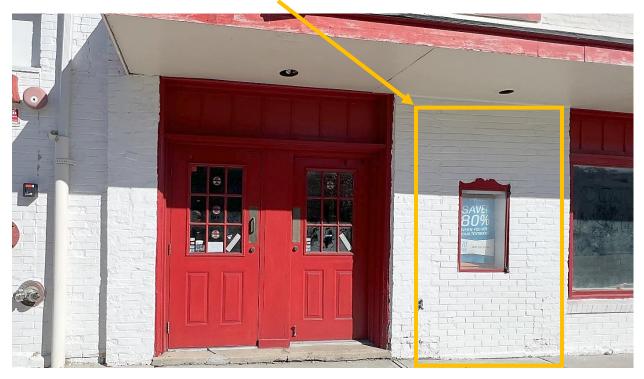
The first bay is composed of a non-historic contemporary double-door entry with a non-historic concrete step. A single door opening to the east at the second bay has been infilled with incompatible type brick, painted over and a non-historic small display box added.

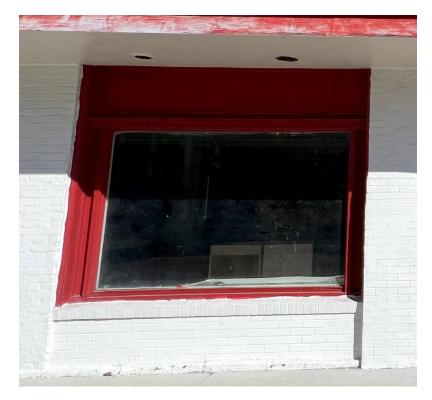
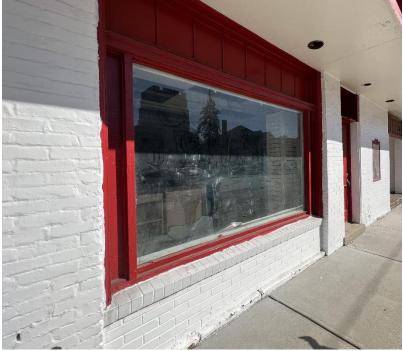
A plate glass picture window at the third bay has been added resting on a knee wall composed of non-historic brick, inconsistent with the Federal style.

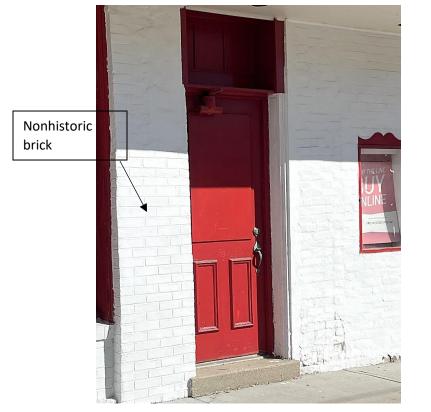
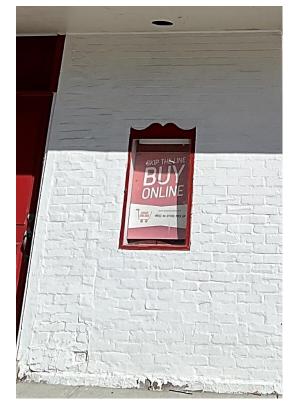
The non-historic contemporary faux raised panel single door with concrete step has been walled over on the interior and is inoperable. The wall to the west of the door is non-historic brick. A small display box has been added to the east of the door with further alterations noted in the brick wall where a single door entry was infilled.

Interior location of walled over inoperable single door

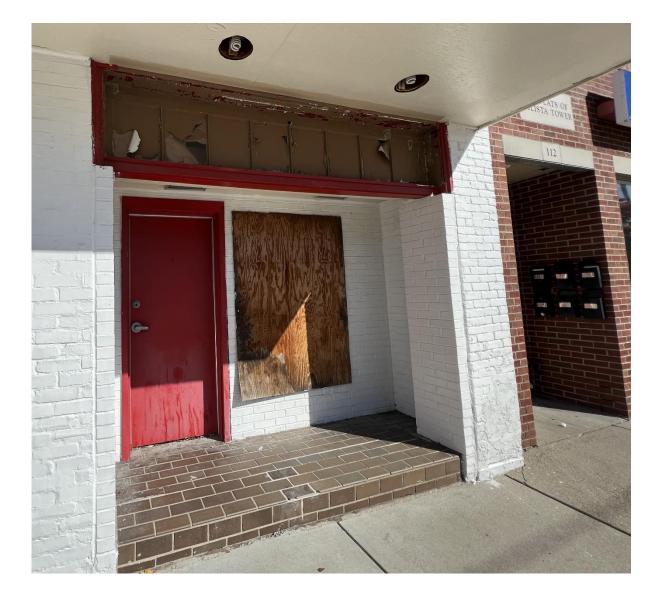
The recessed east end bay is a non-historic alteration with red tile entryway, single door and contemporary brick walls. It is unknown what the boarded-over area is covering. This was a garage door entry when used as a car dealership.

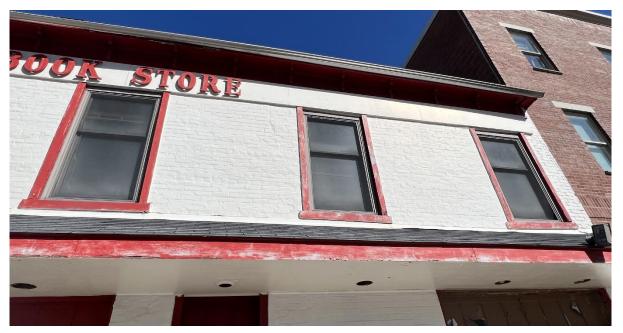
The second floor window fenestration pattern remains, with vinyl replacement windows installed in openings and simple painted non-historic wood trim concealing evidence of stone sills.

A non-historic sign board conceals evidence of stone lintels at the second floor.

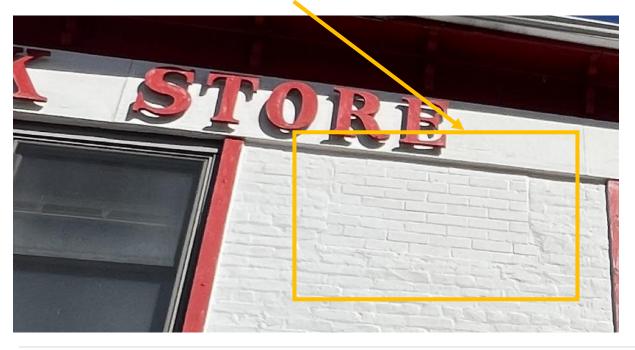
White paint conceals evidence of alterations to the exterior and incompatible brick repair.

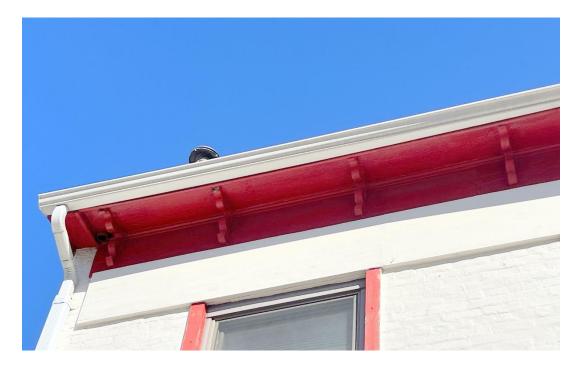
Brackets are not representative of the Federal style and do not appear to be a historic nor are they a characterdefining feature of the building.

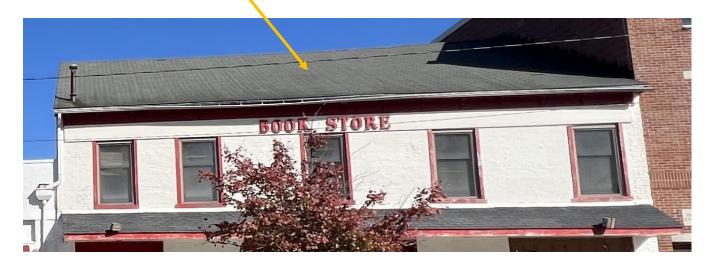
A central chimney below the roof ridge has been removed.

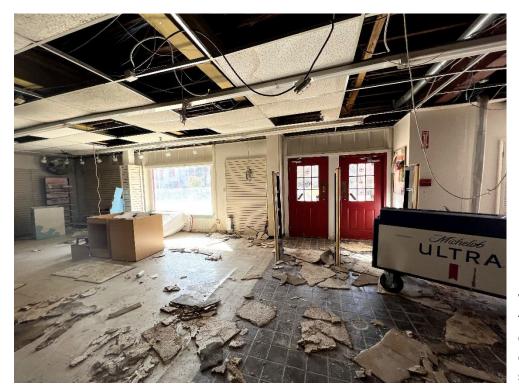
View of First Floor south façade wall, vinyl and ceramic tile flooring, drop ceiling, camera direction south

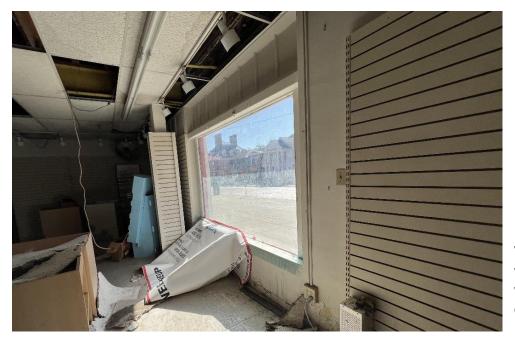
View of First Floor picture window, gypsum and slat wall materials, camera direction southeast

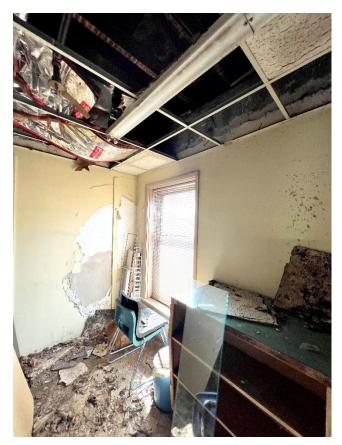
View of Second Floor vinyl replacement window, nonhistoric trim, gypsum walls, drop ceiling and black mold, camera direction southeast.

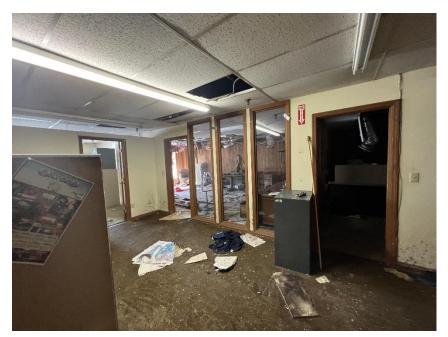
View of Second Floor non-historic trim, gypsum walls, drop ceiling and black mold, camera direction southwest.

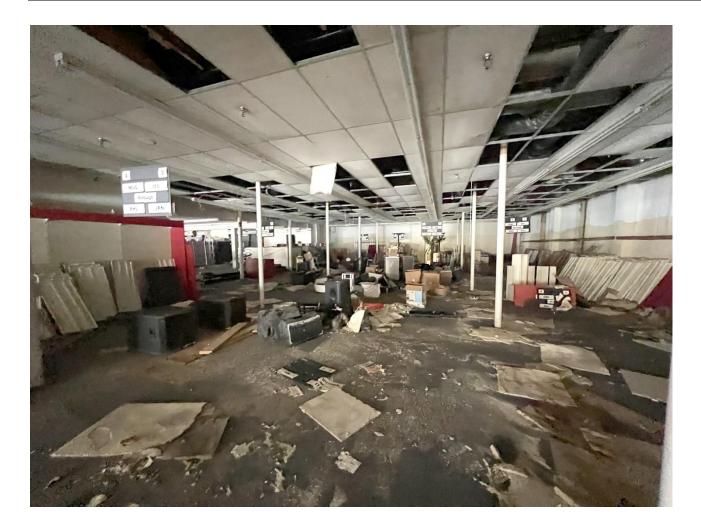
View of rear 108 E. High/Parcel H4100003000169, camera direction north.

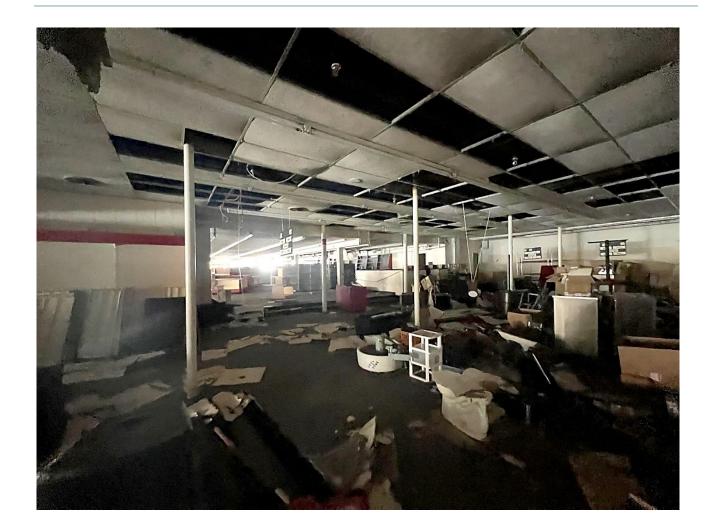
View from rear portion of 108 E. High to 13 N. Poplar portion, camera direction northwest

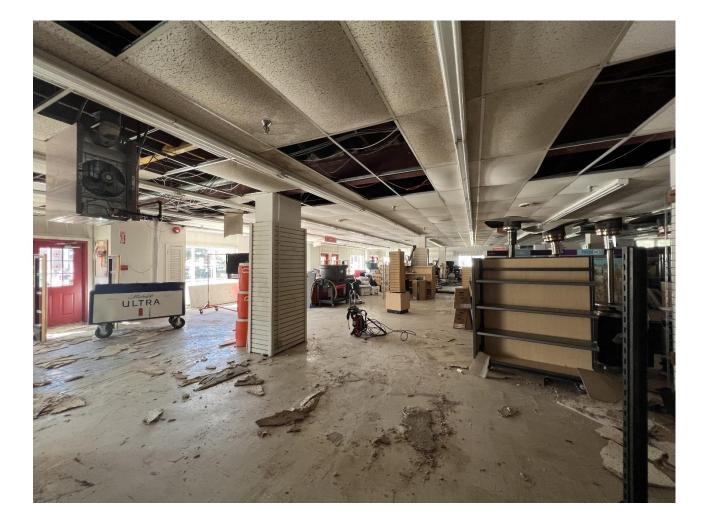
View of 110 E. High/Parcel H4100003000173 from 108 E. High

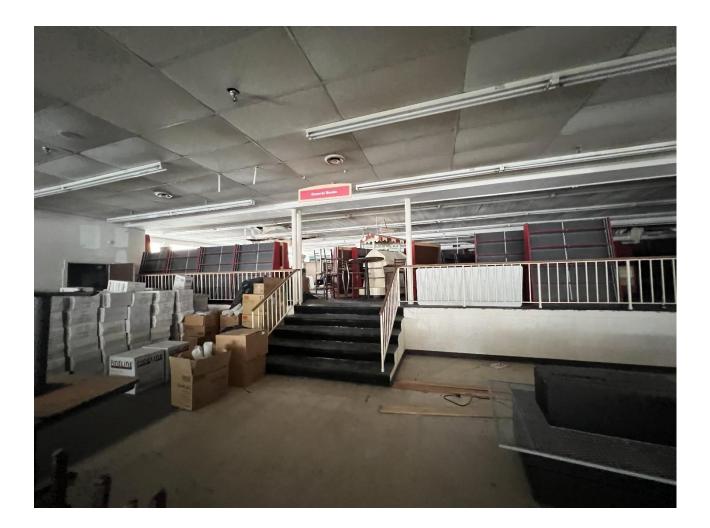
View of 13 N. Poplar Street/Parcel H4100003000168 portion of the building connecting to 108 and 110 E. High, camera direction north.
